PHYTOTOXICOLOGY ASSESSMENT
SURVEY
IN THE VICINITY OF
LAMBTON COUNTY LANDFILL
SITE, SARNIA, 1991

ARB No. 166-91-PHYTO

ARB No. 166-91-Phyto
Author George N. Vasiloff

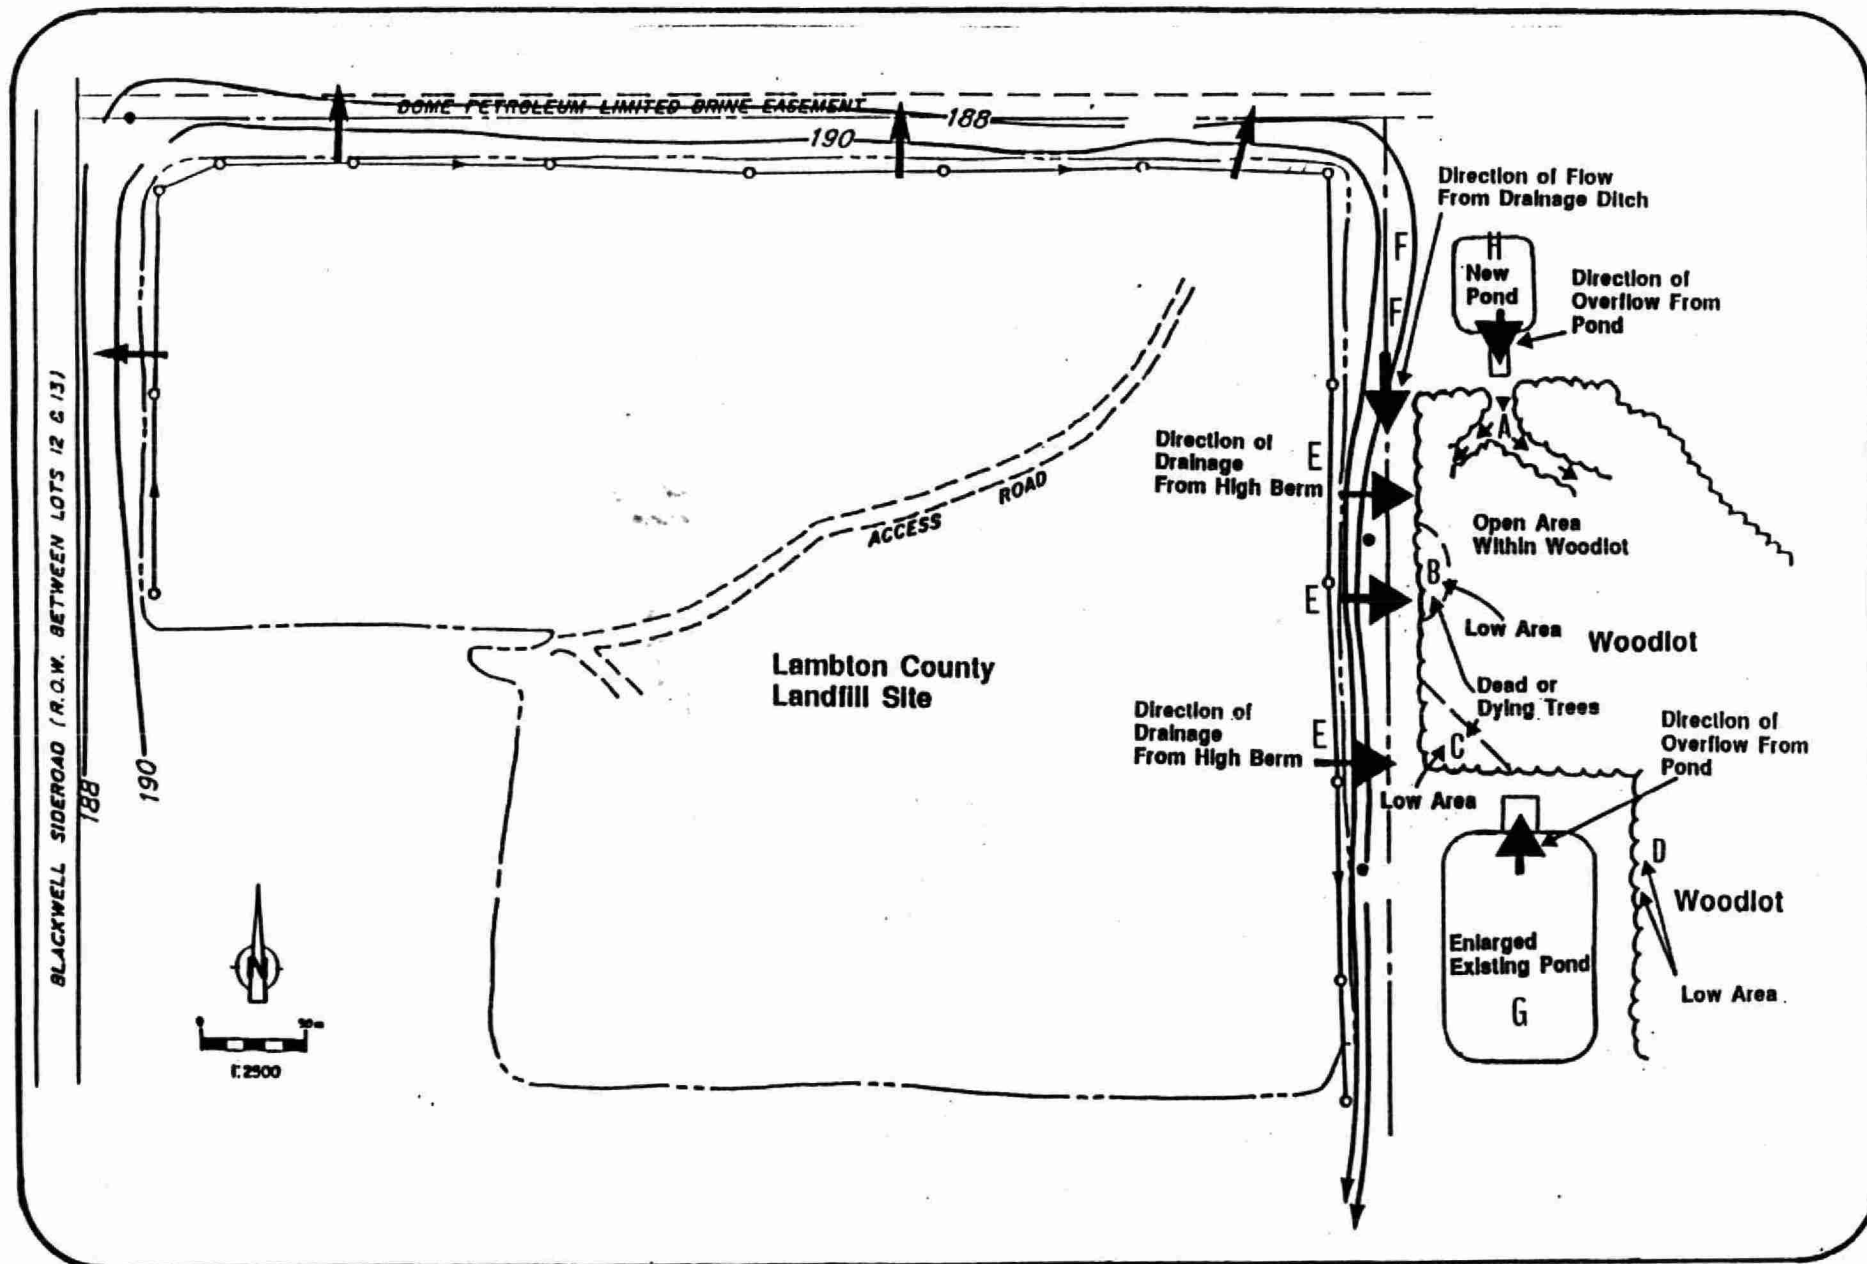
FIGURE: 1 Location of Woodlot in Relation to Lambton County Lanfill Site

Phytotoxicology investigators A. Kuja and G. Vasiloff visited the Lambton County landfill site on September 10, 1991. Figure 1 shows the location of the small woodlot in relation to the landfill site and associated structures. A number of dead and dying silver maple trees were examined at three distinct locations (Sites A, B and C) within the woodlot located immediately east of the landfill site.

The greatest number of affected trees were situated at Sites B and C. At Site B, standing water covered the area surrounding the trees. At Site C, the soil was very muddy and water marks visible on tree trunks indicated that the flood waters had been at least 40 cm deep. At Site D, no dead or declining trees were observed. However, the soil was muddy and high water marks were visible on tree trunks.

The eastern perimeter of the landfill site consists of a massive berm that angles down severely to near the edge of the woodlot. Locations along the berm are identified as Site E in the figure 1. Several years ago, a keyed berm was installed along this stretch of this structure. This procedure involves the excavation of clay from a trench along the berm down to the compacted clay base. The excavated clay is compacted and placed back within the trench. A leachate collection pipe is installed in the middle of the compacted clay in the trench. From an engineering standpoint, a keyed berm constructed in this manner is considered impervious to the penetration of leachate from the landfill site. Sarnia Ministry staff have indicated that the keying was undertaken to prevent leachate from leaking from the landfill site. Although the decline of the trees is not a direct result of the construction, grade changes associated with the construction likely caused additional surface waters to collect within the low areas of the woodlot.

Farther north along the berm (Site F, Figure 1), the base of the berm was graded in such a way that surface water is channelled and flows in a southerly direction and ultimately drains into the western edge of the woodlot.

Immediately north and south of the woodlot, the County has constructed two sedimentation ponds. The southern pond (Site G) was being enlarged during the Phytotoxicology visit. This pond was intended to collect surface waters from the landfill and accept treated water from the leachate treatment plant at the site. A series of overflow pipes have been installed at the north end of the pond to drain away excess water. The pipes lead to an external rock bed that is slightly higher than the grade of the adjacent woodlot. Therefore, overflow waters from the pond would drain into the woodlot. Trees examined along this location indicate that water had been at least 40 cm high at some point during the past growing season.

The smaller pond, north of the woodlot (Site H) was constructed in a similar fashion to the south pond. Discharge from the overflow pipes and rock bed flow directly to the woodlot because of the grade differential. Although high water marks were not observed on woodlot trees, the two paths taken by the waters were clearly defined. Waters flowing along the southwest route appeared to gravitate to the low area at Site B.

The construction of an adequate drainage to direct storm water around the woodlot and other appropriate locations should prevent further flooding and loss of trees.

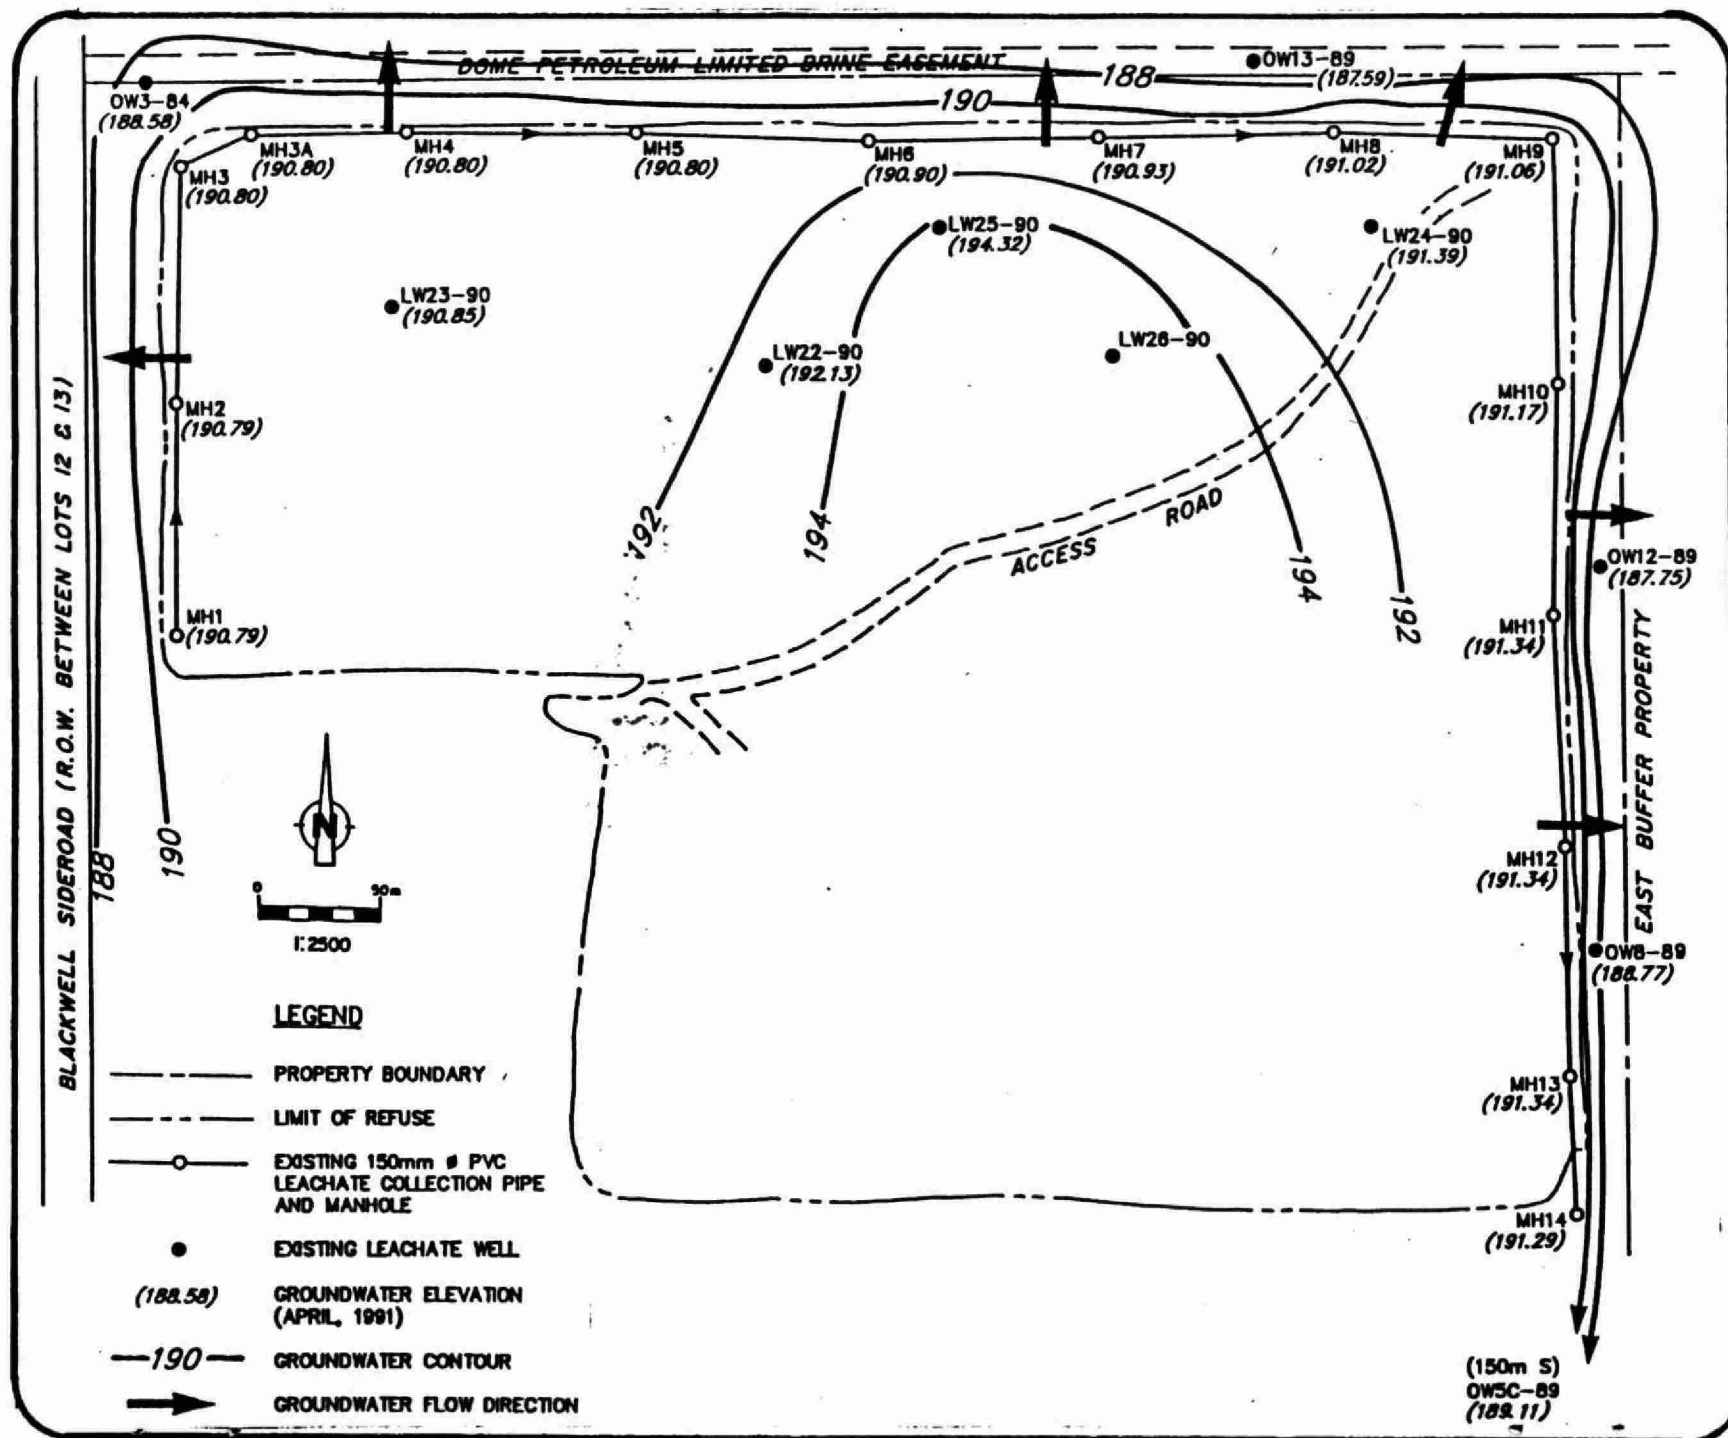
FIGURE: 2 Lambton County Landfill Site Showing Groundwater Potentiometric Surface

Examination of the berm and other landfill site-related structures adjacent to the woodlot indicated that grade changes had caused surface drainage waters from a number of locations to collect at the edge of the woodlot. Figure 2 is a view of the landfill site showing the groundwater potentiometric surface. This figure shows elevations of the perimeter areas of the landfill site and drainage flow directions.
